FORCE TROLLING MOTOR CABLE-JUNCTION-BOX SEAL REPLACEMENT**PRODUCTS AFFECTED**

Force Trolling Motor, 50" and 57" models.

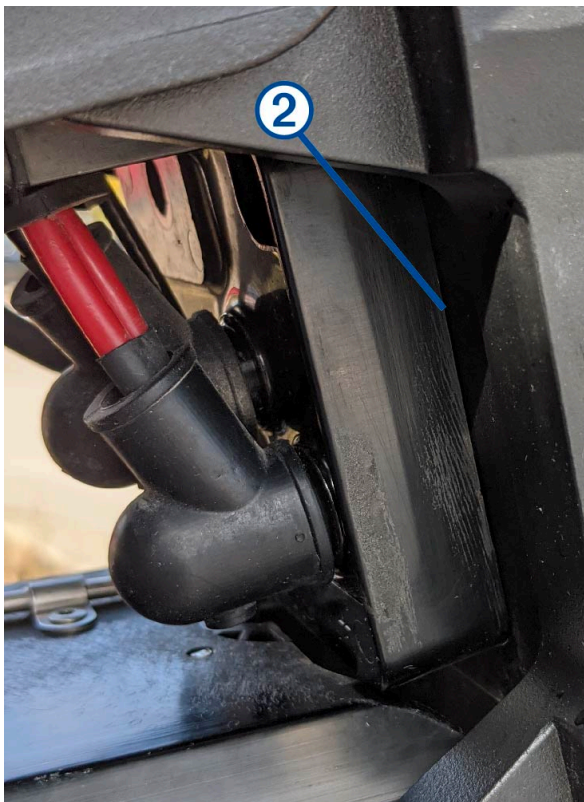
**Motor without the Seal
Installed**

In certain rare situations, especially during or after use in salt water, water may enter the cable-junction box and could lead to a brief electrical fire. Note that the cable-junction box materials are flame retardant and self-extinguishing. These factors help limit the scope and duration of any potential brief electrical fire.

You must replace the seal between the cable-junction box and the steering housing.

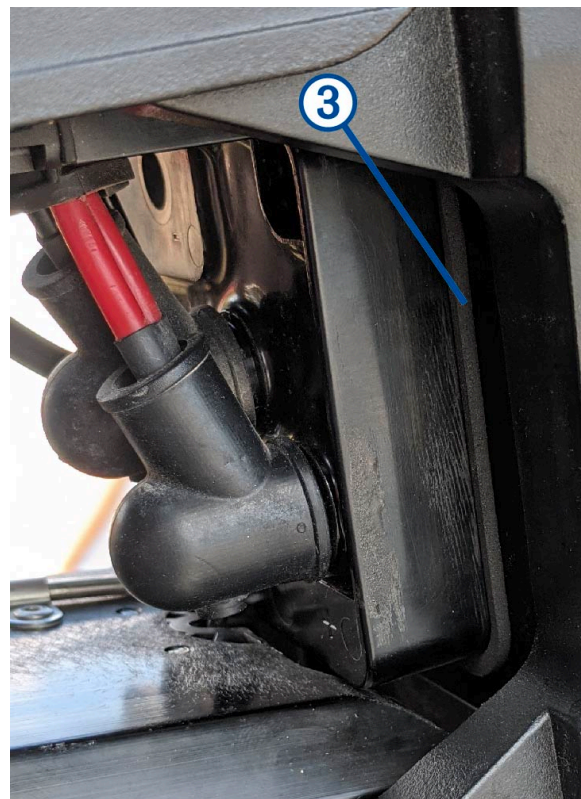
**Motor with the Seal
Installed**

If your motor has the seal installed, you can see the additional layer between the cable-junction box and the steering servo housing ③.
