FORCE TROLLING MOTOR CABLE-JUNCTION-BOX SEAL REPLACEMENT**PRODUCTS AFFECTED**

Force Trolling Motor, 50" and 57" models.

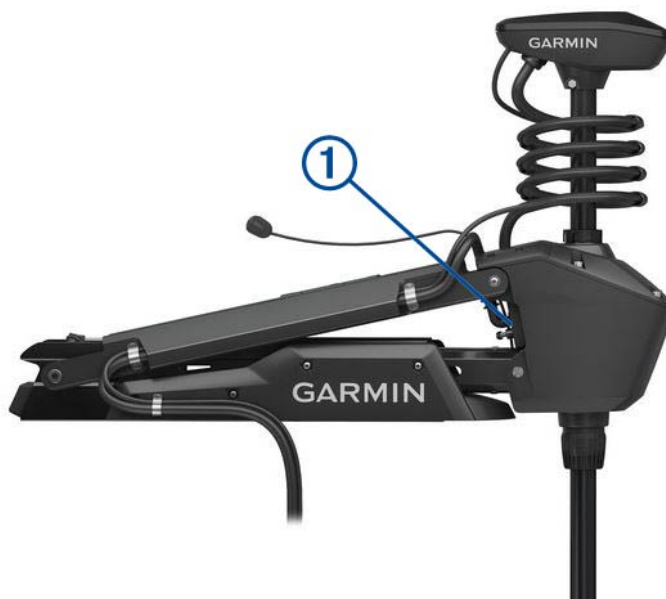
In certain rare situations, especially during or after use in salt water, water may enter the cable-junction box and could lead to a brief electrical fire. Note that the cable-junction box materials are flame retardant and self-extinguishing. These factors help limit the scope and duration of any potential brief electrical fire.

1. Place the trolling motor into the deployed position so you can see the cable-junction box ①.

You must replace the seal between the cable-junction box and the steering housing.
